GROUP	MODEL
ELE	2023MY EV6 GT (CV GT)
NUMBER	DATE
295	May 2023

TECHNICAL SERVICE BULLETIN

SUBJECT: **VCMS BATTERY CHARGING LOGIC IMPROVEMENT**

This bulletin provides the procedure to update the software logic of the Vehicle Charging Management System (VCMS) system on some 2023MY EV6 GT (CV GT) vehicles produced from June 21, 2022 through March 28, 2023, which might experience inoperable High Voltage Battery (HVB) charging issues due to excessive high temperatures at the combo charger inlet module assembly. Follow the procedure outlined in this publication to apply the improved logic to the 'VCMS' system using the KDS ECU Upgrade function as described in this bulletin. For confirmation that the latest reflash has been applied to a vehicle you are working on, verify the ROM ID using the table on page 3 of this bulletin.

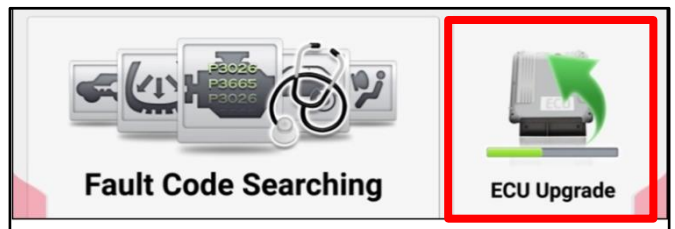
5. The KDS will check the server for recently uploaded Events and then automatically download Upgrade Event #674.

After the download is complete, the program will shut down to install. Please wait until the program restarts.

KDS screenshot shown above is for demonstration purposes only. Events shown in screenshot are not applicable to this bulletin.

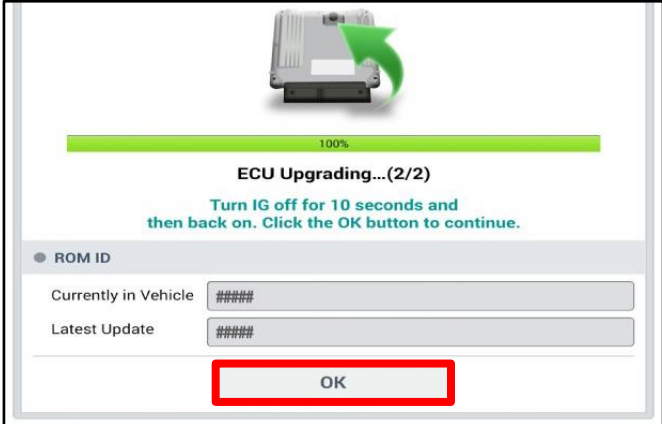
- Once the upgrade is complete, select 'OK' to finalize the procedure.
