HYUNDAI Technical Service Bulletin	GROUP EV SYSTEMS	NUMBER 23-EV-003H
	DATE MARCH 2023	MODEL(S) Ioniq 5 Electric (NE1)
SUBJECT: VEHICLE CHARGE MANAGEMENT SYSTEM (VCMS) UPDATE

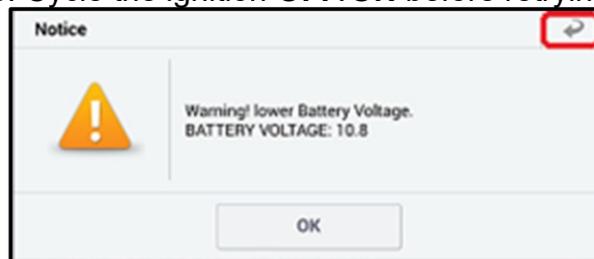
! WARNING**GDS Vehicle Battery Voltage:**

- If the voltage is below 12 volts as per the GDS warning, then select **Back** and run the vehicle at least 15 minutes to reach an adequate battery state of charge to prevent an ECU Update failure. Cycle the ignition **OFF/ON** before retrying ECU update again.

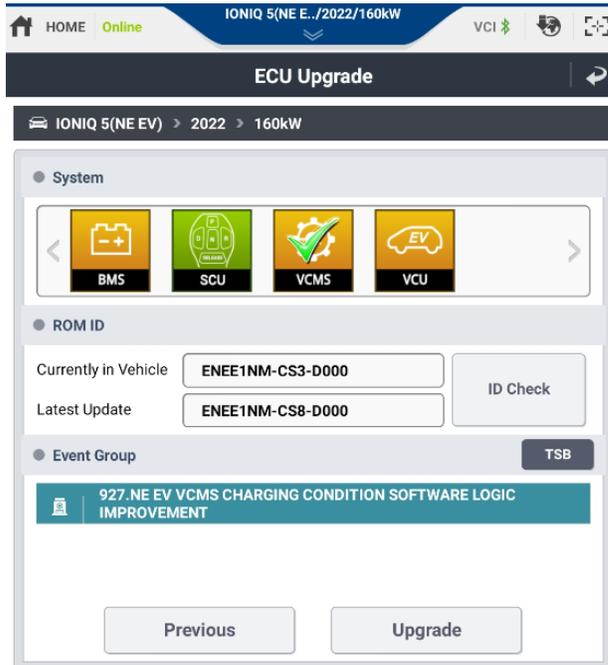
1. Perform the VCMS Update in Auto Mode.
 - a. Use the Auto Mode ID Check to verify the VCMS ROM ID before updating the software.

b. After the ECU Upgrade process shows 100% complete, cycle the ignition key to **OFF** for at least 10 seconds to reset the control unit.
